REPORT No. 56/BT/2019

Subject:	Testing the IP 68 ingress protection rating of water meter housing SMART
Ordered:	Apator Powogaz S.A., ul. Klemensa Janickiego 23/25, 60-542 Poznań, Poland
Project No.:	UP/BT-25109/OR
The date of the report:	30.04.2019
The date and place of test::	26-30.04.2019, the research hall C in KOMAG Institute of Mining Technology at Pszczyńska 37 in Gliwice, Poland

Testing the IP 68 ingress protection rating, according to the requirements of the PN-EN 60529:2003+A2:2014-07.

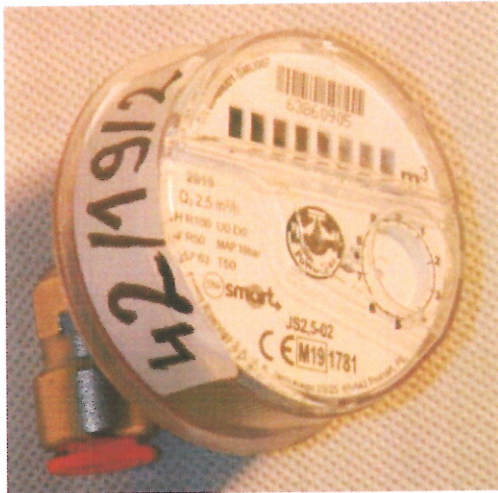
Fig. 1. Water meter housing SMART

Water meter housing SMART with a serial number 63860963 was tested for the first characteristic numeral IP 6X (Fig. 1). Water meter housing SMART with a serial number 63860905 was tested for the second characteristic numeral IP X8 (Fig. 2). In the Laboratory, they have been consecutively marked with sample numbers: 42/19/2 and 42/19/1, according to the R-BT/9 procedure.

RESULT IS POSITIVE

Dust did not get inside the tested counter housing.

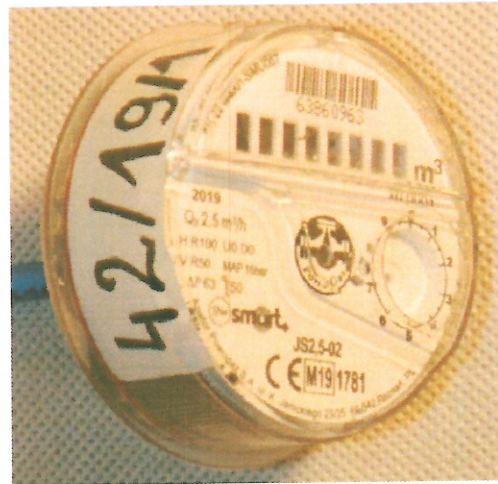
Fig. 2. Water meter housing SMART

RESULT IS POSITIVE

The Orderer defined the depth of immersion of housing to 1,2 m below the water surface. The test was carried out for 24 hours. Water did not get inside the tested counter housing.
